JOB EXAMPLES

POOL RESTORATION INSIGHTS

POOL PLASTER AND PAINT REMOVAL

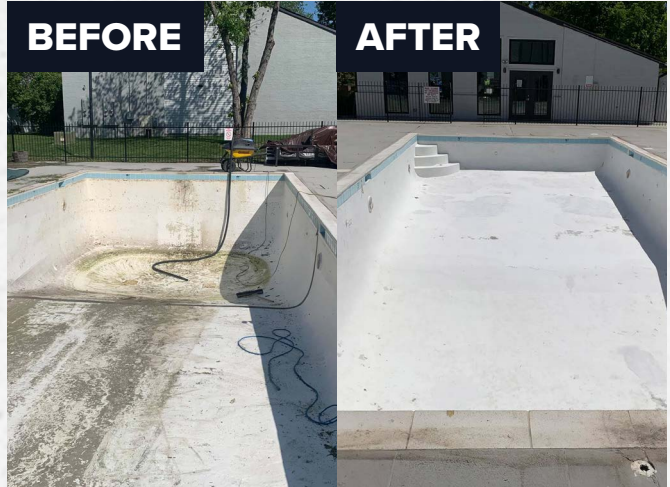
➤ A business owner in Kentucky used DUSTLESS BLASTING® equipment to remove several layers of paint and plaster from an apartment complex pool in need of resurfacing. The contractor was also responsible for cleaning up after the job so that the plaster company could immediately resurface the pool.

JOB LENGTH: 10.5 hours	ABRASIVE MEDIA: 36 bags of crushed glass
NOZZLE TYPE: XL Performance Size: #6	JOB SIZE: 1800 SQ FT
EQUIPMENT: DB800® Mobile XL	BLASTING METHOD: 100% dry

Crushed glass was the ideal abrasive choice, for its low cost, angular shape, and environmentally inert characteristics.

The XL Performance nozzle increases abrasive particle velocity, resulting in improved production rates. It was a great choice for this large pool with multiple layers of paint. It allowed the contractor to use a larger standoff distance, covering more ground in less time.
